TEST REPORT

CEPRI-EETC08-2019-0543 (E)

Object: Plug in type dry GIS termination for 64/110 kV

Type: WYJZGGC 64/110 1×1600

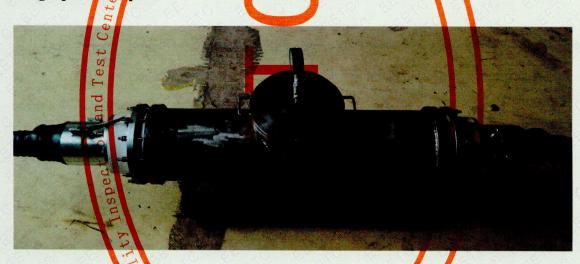
A.2 Photograph of sample

The sample to be tested has been installed by the manufacturer on a XLPE insulated single core cable with rated voltage 64/110 kV and having a cross-section of 1600 mm², the type and size of cable is ZB-YJLW02-Z 64/110 1×1600.

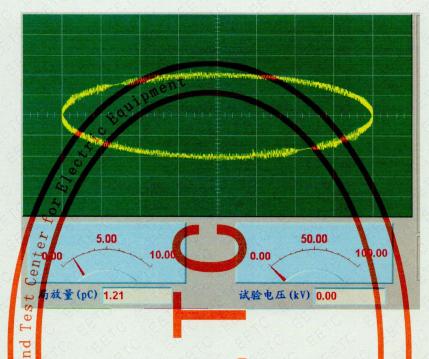
- D.2 Oscillograms of partial discharges
- D.2.1 The background noise during partial discharge tests

6	Partial discharge test at ambient temperature	No detectable discharge from the test assembly at 96 kV under a background noise	No detectable discharge was found from the test assembly at 96 kV under a background noise of 1.21 pC	Passed	
7	Lightning impulse voltage test	The test assembly shall withstand without failure 10 positive and 10 negative voltage impulses of 550 kV	No breakdown occurred on the test assembly at 10 positive and 10 negative voltage impulses of 550 kV	Passed	
8	Power frequency voltage test after lightning impulse voltage test	The test assembly shall be subjected to a power frequency voltage test at 160 kV for 15 min, and no breakdown of the insulation shall occurred	The test assembly have been subjected to a power frequency voltage test at 160 kV for 15 min, and no breakdown of the insulation was occurred	Passed	
9	Examination	As per clause 1.6 of content in this report	No signs of deterioration which could affect the system in service operation was found	Passed

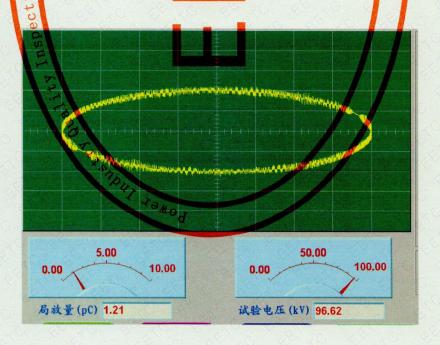
D.2.2 The oscillogram of partial discharges at 96 kV (After heating cycle voltage test at high temperature)
